# Manhole Inspection Summary

## Manhole # S17K1\_013MH

Insp Date: **4/30/08 12:39 PM**

**Location** Address: **2306 gable av**

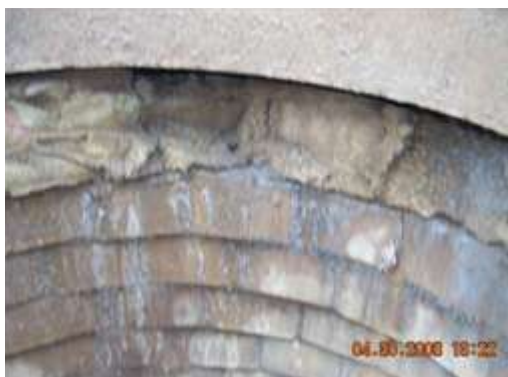
Defect 2

Condition: ☐ Sound ☐ Cracked ☐ Root Intrusion ☐ Loose Brick ☒ **Deteriorated**

deteriorated chimney

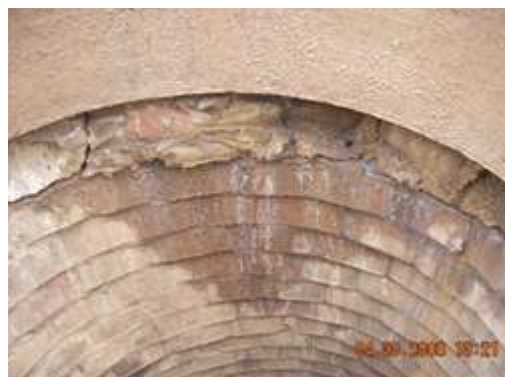
Defect 1

Infiltration: ☐ None ☒ **Joint** ☐ Cracks ☐ Mortar ☐ Roots ☐ Wall

infiltration @ chimney/frame joint

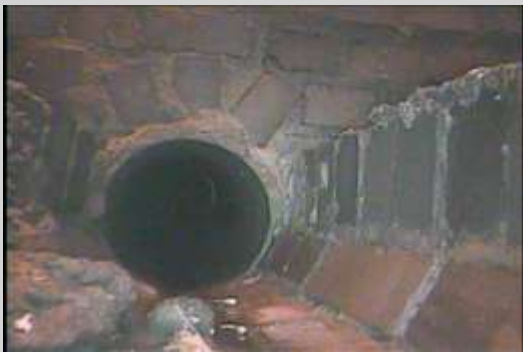
12 O'Clock Outflow

Pipe Height: **8.4** (in.) Rod and Bar (Angled)  
Pipe Material: **Clay** ☐ Pipe Lined  
Invert Depth: **10.62** (ft.) Flow Characteristics: **Slow**  
Deposits: ☐ None ☐ Mud ☒ **Sludge** ☐ Debris ☐ Grease  
Silt Depth: **2** (in.) Deposits Extent: **Light**  
Infiltration: **None** Pipe Seal Cond: **Sound**

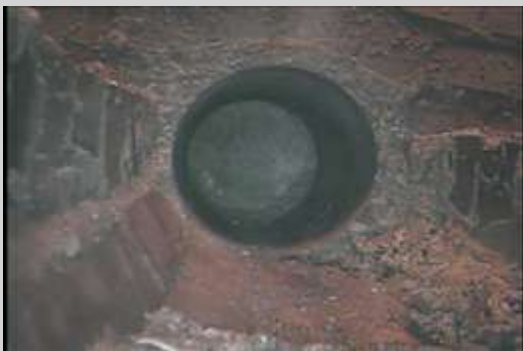
6 O'Clock Inflow

Pipe Height: **8.4** (in.) Rod and Bar (Angled)  
Pipe Material: **Clay** ☐ Pipe Lined  
Invert Depth: **10.26** (ft.) Flow Characteristics: **None**  
Deposits: ☒ **None** ☐ Mud ☐ Sludge ☐ Debris ☐ Grease  
Silt Depth: **0** (in.) Deposits Extent:  
Infiltration: **None** Pipe Seal Cond: **Sound**

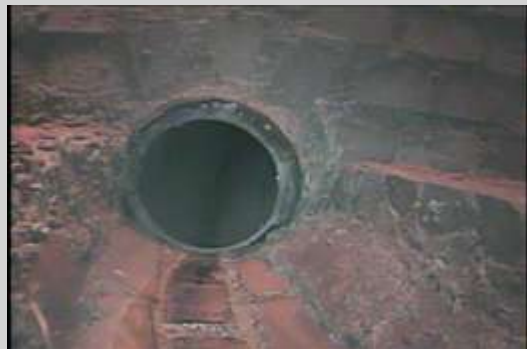
9 O'Clock Inflow

Deposits: ☒ None ☐ Mud ☐ Sludge ☐ Debris ☐ Grease

Infiltration: **None**

Pipe Seal Cond: **Sound**
